### Poplar River First Nation Community Based Monitoring Project:

Droning on for Climate Monitoring: Equipping Poplar River First Nation With Remotely Piloted Aerial Systems and Data Analysis Capacity for Measuring Algal Blooms and Shoreline Erosion on Lake Winnipeg - 2021-2024

Year 4 (2024) Water Quality Monitoring & Remotely Piloted Aircraft System Training Field Activity Report

> By: Poplar River First Nation & North/South Consultants Inc. March 2025

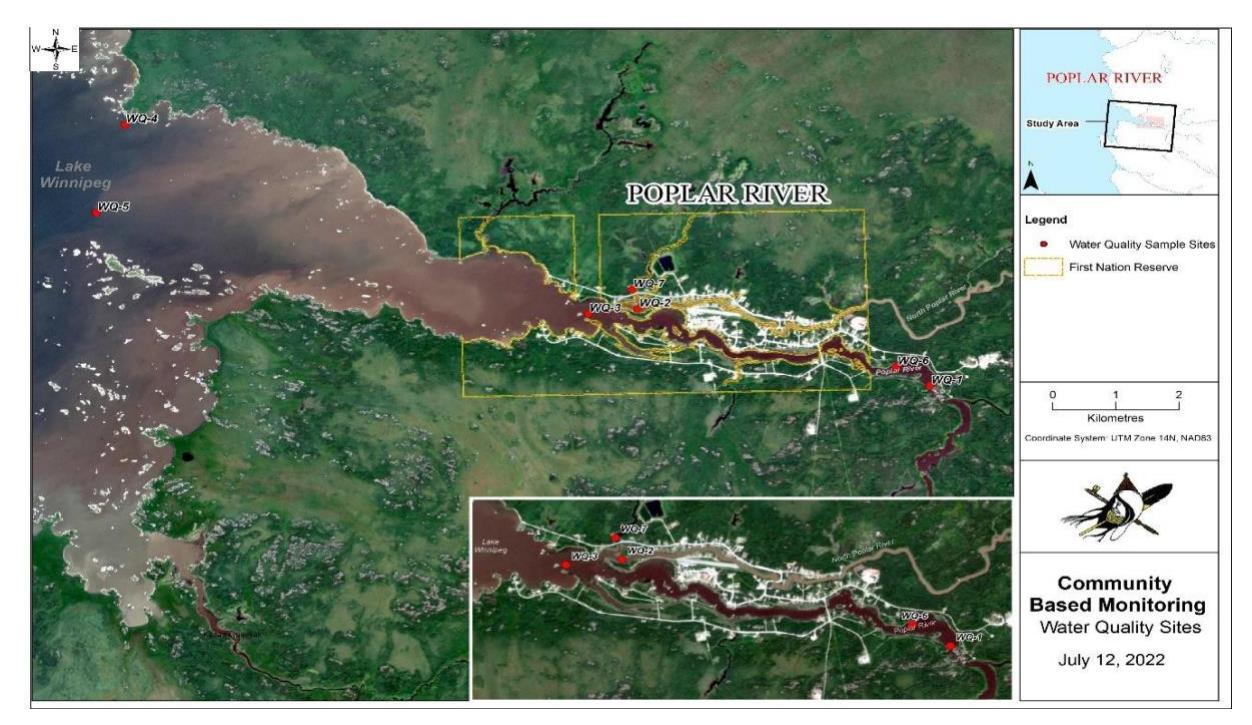
**Figure 1:** Water quality sample sites 2024, in the Poplar River, North Poplar (Franklin) River and Lake Winnipeg, Manitoba.

A total of seven sampling sites covering the Franklin and Poplar Rivers and Lake Winnipeg were selected for study (Table 1; Figure 1). The first sampling site was moved back to its original year 1 location during year 3 and 4 due to lower water levels. The new site, WQ 6, created 400 meters downstream from WQ 1, will be used as an alternate site in the future if high water does not allow sample collection at WQ-1. The WQ 2 site is approximately 300 m upstream of the Lagoon Discharge Creek that flows into the Franklin River. The WQ 3 site is located where the flow from the Franklin River meets the Poplar River. Sites WQ 4 and WQ 5 are in Lake Winnipeg and were selected to represent nearshore and offshore lake environments, respectively. The influence from the Poplar River was determined to be minimal due to the decrease in turbidity at the Lake Winnipeg sites.

Site	Zone	Co-ordinates				
		Easting	Northing	Depth (m)	Site Description	
WQ 1	14 U	619276	5871933	2.3	Reference site upstream of community-Poplar River	
WQ 2	14 U	614648	5873308	3.9	Franklin River-upstream of Lagoon Discharge site	
WQ 3	14 U	613864	5873219	4	Poplar River near confluence of Franklin River downstream of Lagoon Discharge	
WQ 4	14 U	606528	5876597	3.3	Lake Winnipeg Nearshore	
WQ 5	14 U	606072	5875025	6	Lake Winnipeg Offshore	
WQ 6	14 U	618741	5872274	4.1	Alternate reference site upstream of community for use during high water years.	
WQ 7	14 U	614559	5873654	1.6	Lagoon Discharge sampling site

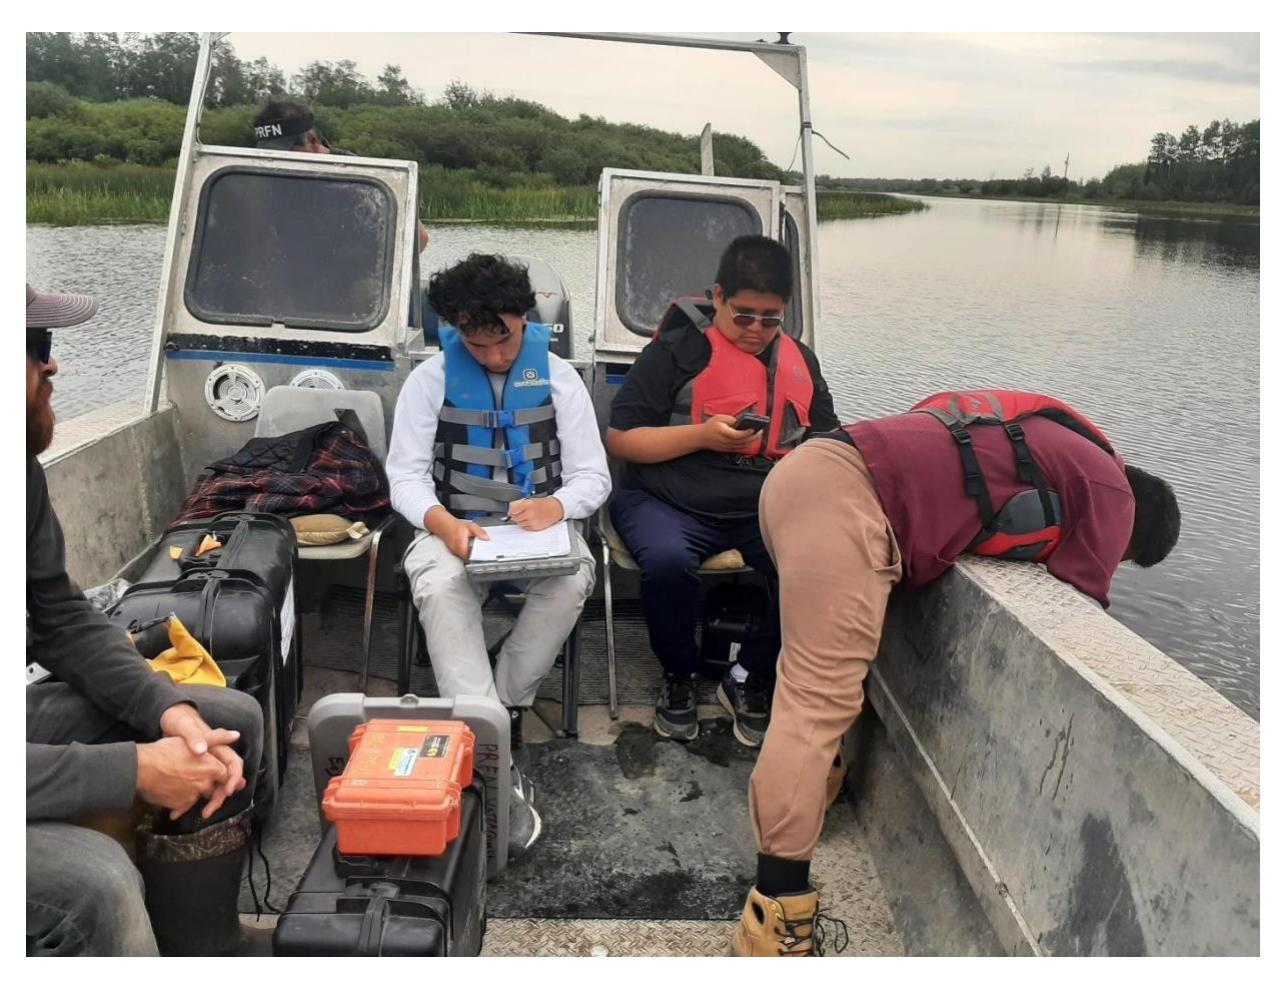
**Figure 3**: Seth FRANKLIN Collecting a water sample in the Franklin River at water quality site WQ-2. Aiden RABLIAUSKAS writes site attributes on the data sheet while Owen BEAR assists the sampler collect water.

Upon arrival at each site, the following information was collected and recorded on field data sheets: Site ID, GPS coordinates, wind speed and direction, weather, cloud percentage, last precipitation, water temperature and depth (Figure 3). To collect a more accurate measurement of water transparency, the average of the Secchi disk reading was recorded for each site, determined by taking 2 depths: 1 on the lift and another when lowering. Prior to site departure, 1 photo was taken in each direction from the sampling location to provide details of the adjacent riparian area.

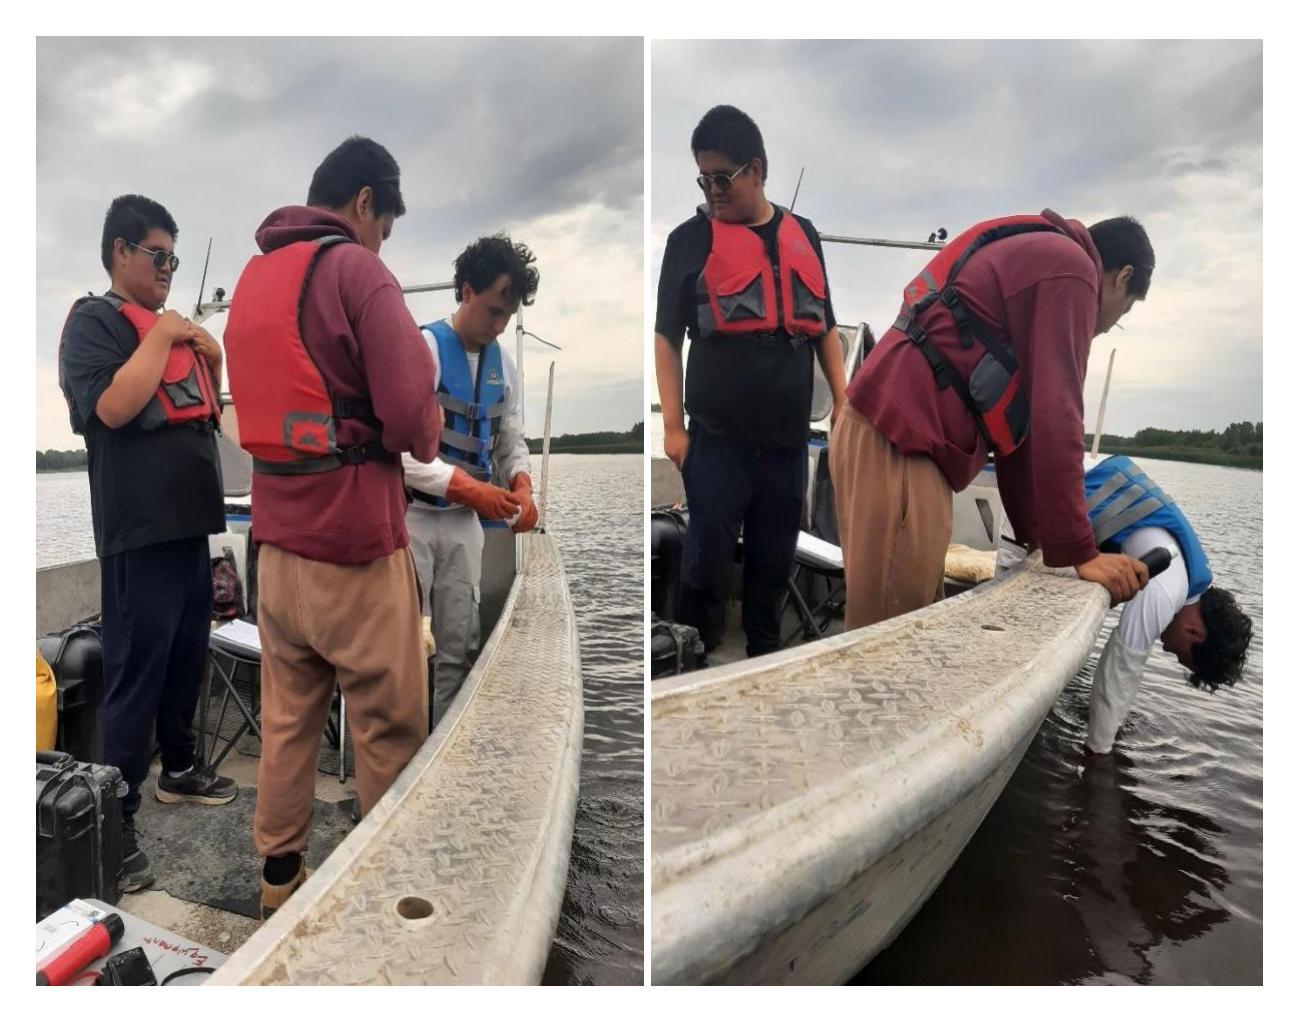
**Figure 4:** Left, Aiden RABLIAUSKAS prepares to take a water sample with shoulder length gloves. Right, Aiden RABLIAUSKAS collecting a surface water quality sample to be submitted to ALS labs for Analysis.

At each site there were three water samples collected for laboratory analysis of chlorophyll, nutrients, and routine analysis. Water samples were collected and sealed approximately one foot below the water's surface to ensure excess nutrients and total suspended solids (TSS) on the surface did not contribute to the sample.

During sample collection the routine sample container was filled and closed approximately one foot below the water's surface, ensuring all air was released from the container. The water collected in the first routine bottle was transferred to the chlorophyll and nutrient sample bottles and was then refilled below the water's surface and then preserved. At each site the water samples were labelled with the site ID (WQ 1, 2, etc.) followed by 1, 2 or 3 identifying the 3 sample containers per site.

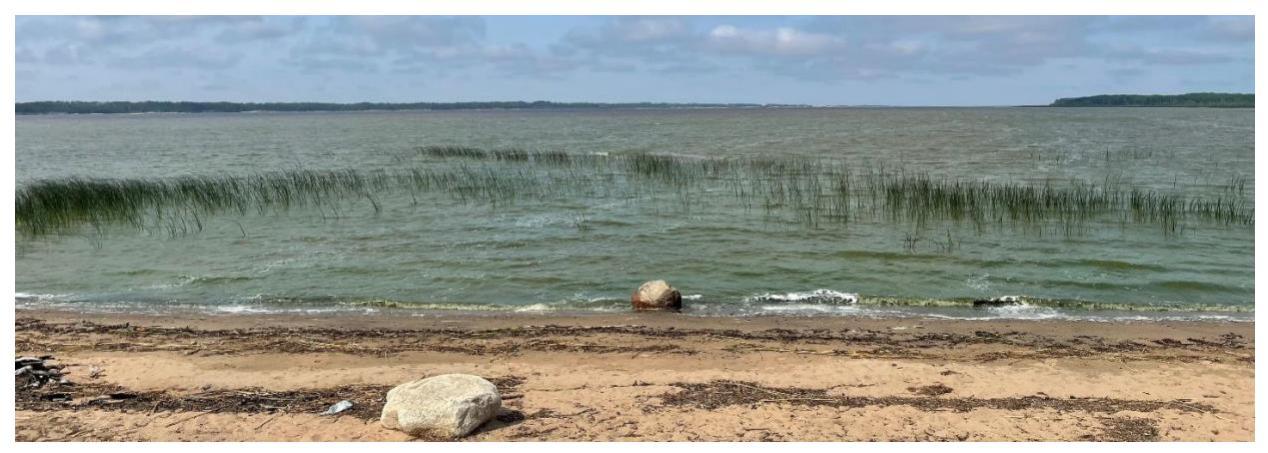
Figure 6: Algae Bloom at the Franklin Beach erosion monitoring site (July, 2023).

Algae bloom severity and extent are the primary concern of this program which is measured by the amount of chlorophyll present in the water. According to the State of Lake Winnipeg Report Second Edition (Manitoba, 2020) from 2008-2016 it was not unusual to find average Chlorophyll-a summer concentrations between 20 and 25 ug/L with a maximum of 35 ug/L during the summer months. However, the chlorophyll-a concentration of 72.6 ug/L found on in July 2023 at WQ-4 (Table 2) is far beyond the normal range (Figure 6). This is believed to be because of the sewage lagoon discharge which was released 4 days prior to sampling.

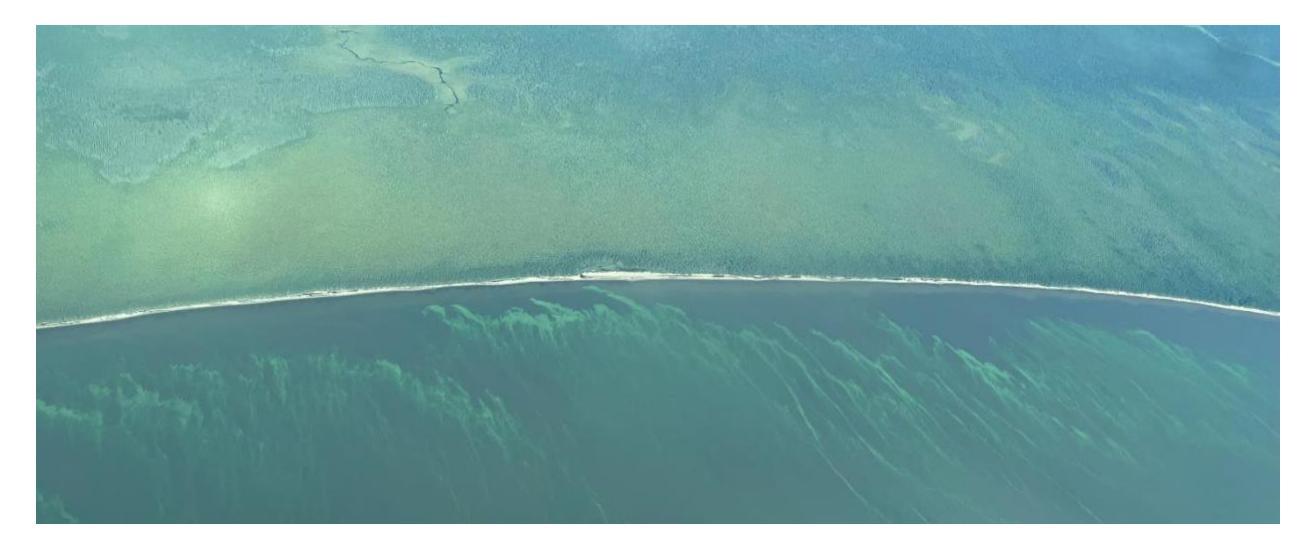
Figure 7: Algae blooms on East shore of Lake Winnipeg 30 km South of PRFN August, 2024.

During the 2024 Sampling season the algae balls were still visually evident at WQ-4 however chlorophyll did not spike the same way it did during the 2023 sampling season. This is likely because sampling did not coincide with a lagoon discharge event. The absence of high algae and chlorophyll this year potentially shows that the lagoon discharge event is causing the increase in chlorophyll-a at water quality sampling site WQ-4. Though future sampling will be required to pinpoint this as a definitive contributing cause of algae blooms at the mouth of the Poplar River since there are many other influences affecting the health of Lake Winnipeg such as agricultural inputs from other river systems (Figure 7).

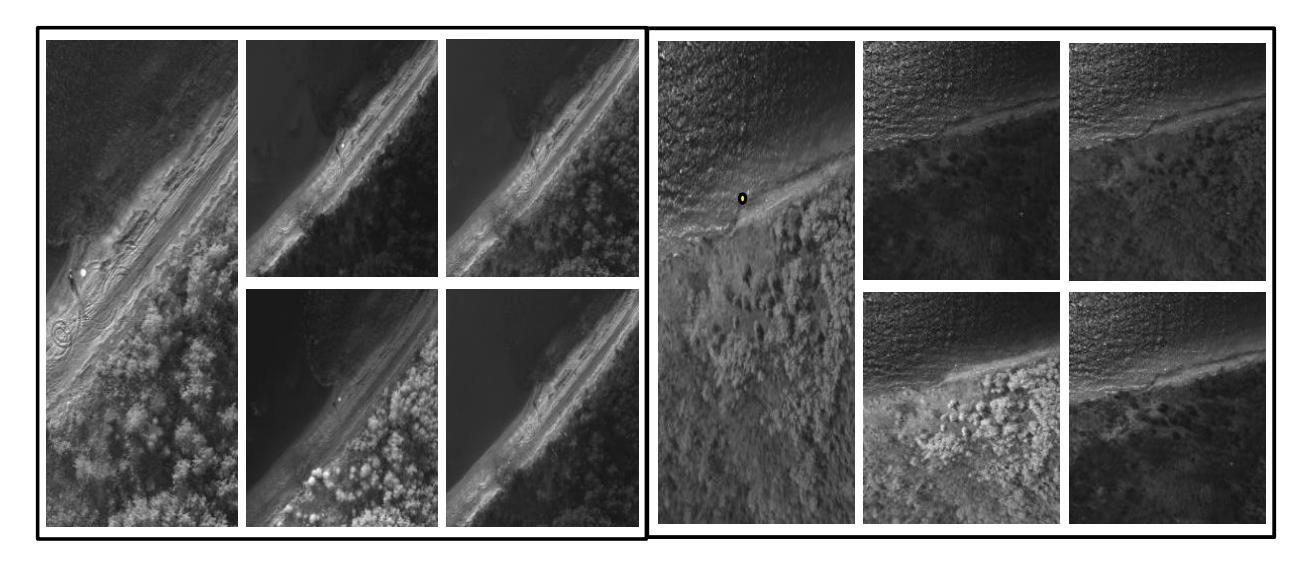
**Figure 9:** Drone Imagery of Franklin Beach showing low water in August 2021 (top 5) compared to high water in June 2022 (Bottom 5). Yellow dot in bottom left photo is location of white dot (drone landing pad) in top photos.

Multispectral camera image data gathered this year will help develop a relationship between the baseline monitoring conducted in 2021 and current lake levels and shoreline retreat in 2024. Individual red, green, blue, red edge and near infrared images (Figure 9) taken at water quality sites and the beach at the end of Franklin Road are layered, stitched together, and analyzed using Using Pix4D Mapper photogrammetric software to view differences in algal blooms over time. Individually these pictures look uninteresting but when layered they create a unique image that can be analyzed in many ways.

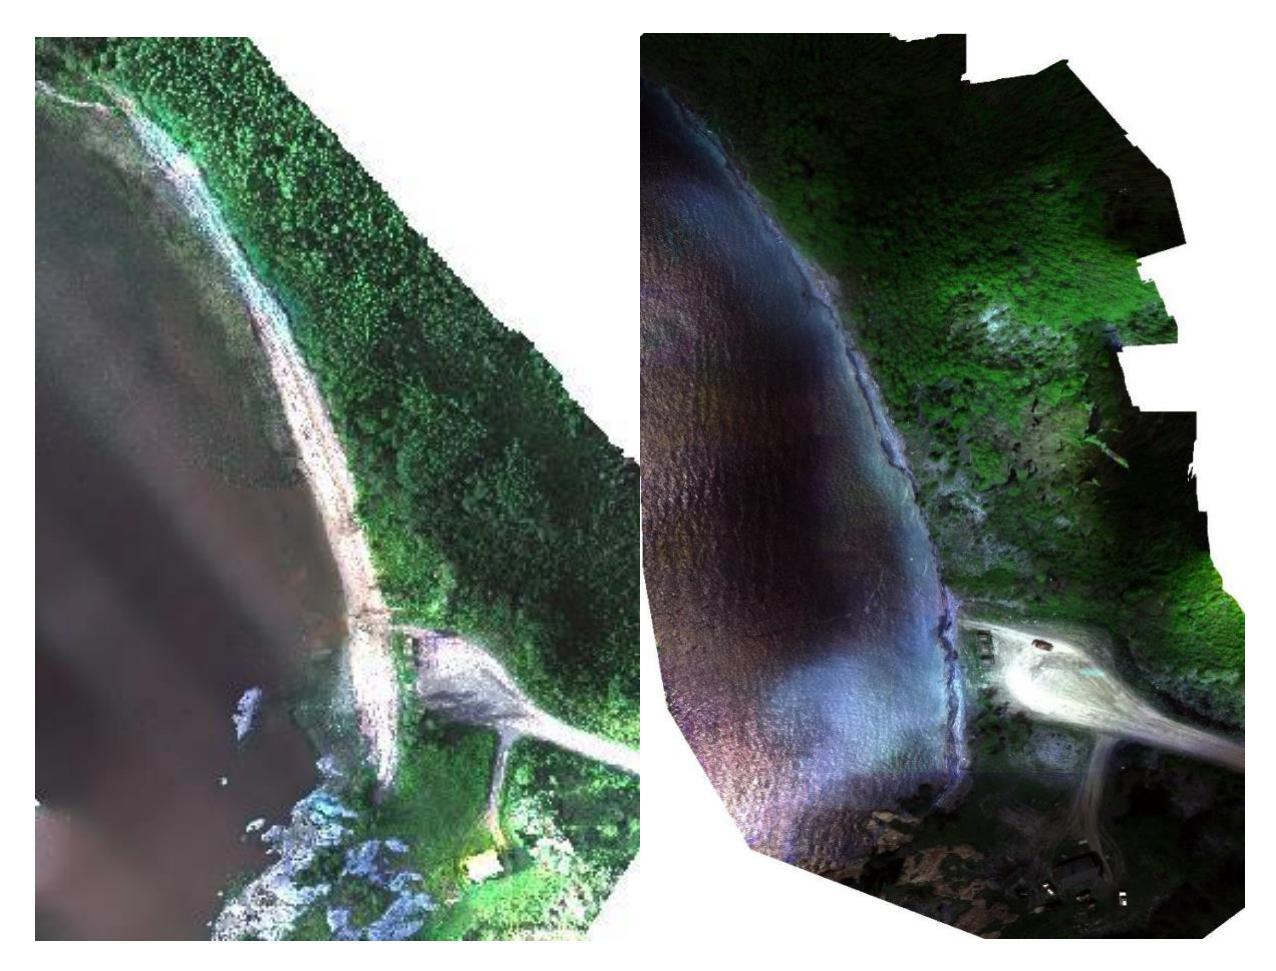
**Figure 10:** Large area (15 acres) mapped at the end of Franklin Road using the red, green, and blue multispectral drone image data collected August 2021 (Left) and June 2022 (Right). Note the difference in the water levels from the left picture (low water) to the right picture (high water)

The beach at the end of Franklin Road (Figure 10) was selected as an area that may show signs of shoreline erosion over time. By analyzing multispectral imagery and digital elevation models (DEMs) generated from the imagery it is possible to map shoreline change over time. Additional data processing and analyses are expected to occur at a later date.

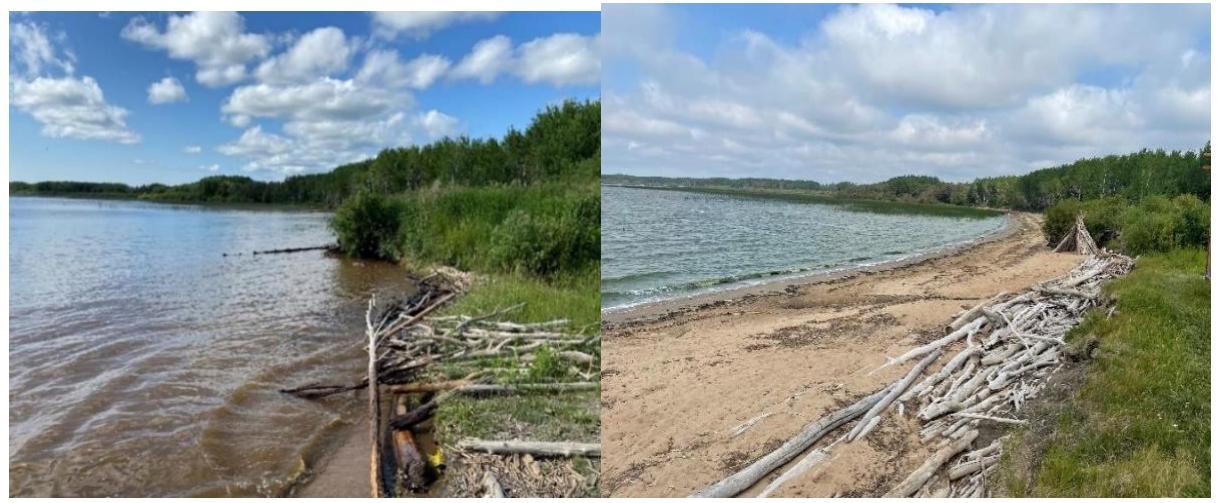
**Figure 11:** Beach at the end of Franklin Road: Left - High water all year in 2022 eroded the soft soil layer under the grass roots of the bank; Right - bank can be seen breaking away in July 2023 causing Cantilever Bank Failure.

After 4 years of monitoring, observations have indicated shoreline erosion is occurring at the beach at the end of franklin road due to water level fluctuations, and wind events. The rate of shoreline erosion is slow but consistent within the 4-year period. In 2022 high water levels persisted on Lake Winnipeg throughout the year which eroded the soft under layer of the banks that is not held together by vegetation. When this happens, the bank is no longer supported underneath and can break off, this type of shoreline retreat is called cantilever bank failure.

In 2023 a crack formed along the shoreline where the unsupported layer started to break away and low water on the beach allowed one foot of bank material to break off from the shore (Figure 11). 2024 brought even lower water therefore the banks were eroded from weather erosion such as surface water runoff and wind. Once the bank begins to detach it becomes unstable and even light erosion such as surface water will cause most of the bank to wash into the water over time. The banks that had been affected in the previous 2 years were completely detached and slumping onto the beach (Figure 12).

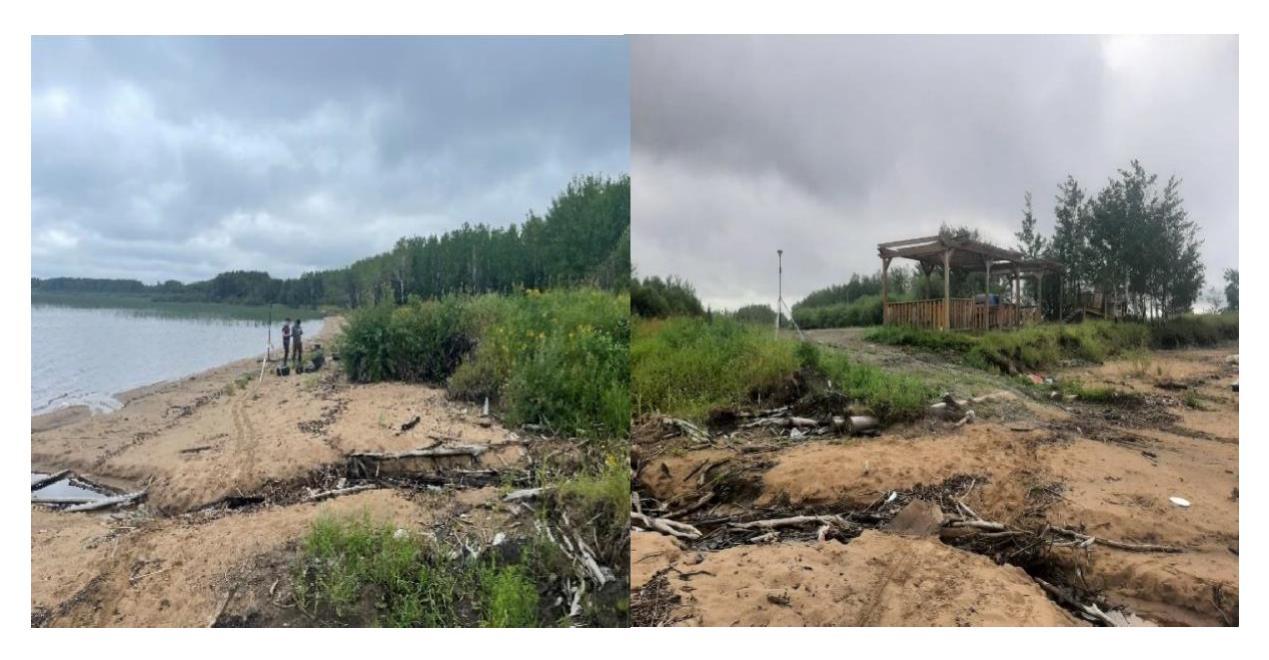
**Figure 12:** left - low water reveals the failed portion of the bank is now fully detached and washing into the lake due to overland runoff in August 2024. Right - Picnic seating areas near the shore at Franklin Beach will need to be moved back as the shoreline continues to erode.

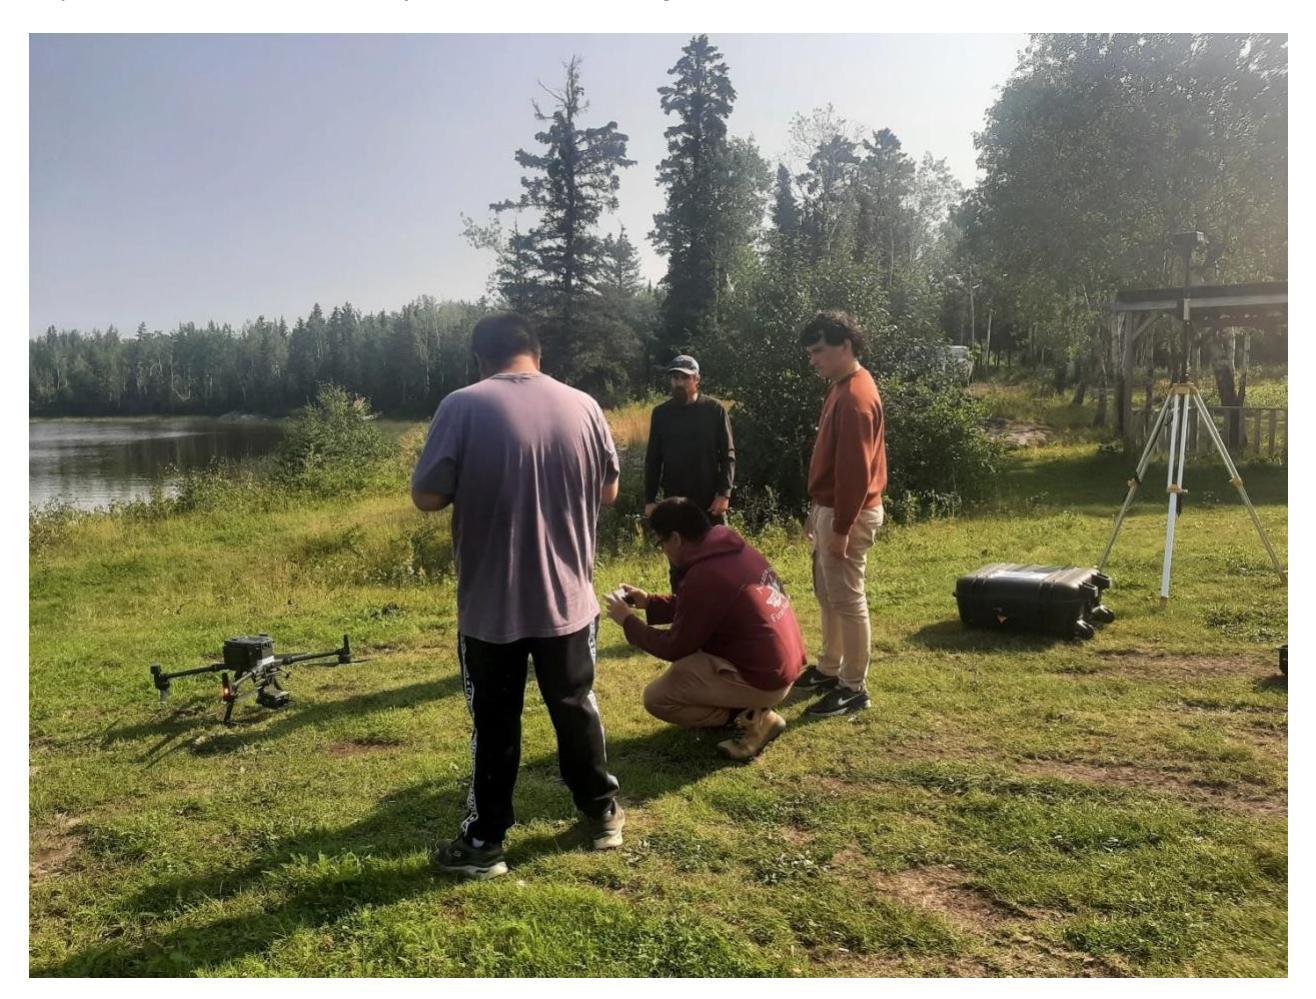
**Figure 15:** PRFN Lands Guardians learning how to use the DJI H20T thermal camera at the rapids upstream of the community on the Poplar River.

PRFN has no access to aerial support such as a helicopter to search for missing people during emergency search and rescue operations. The RPAS with the DJI H20T thermal camera will become an important instrument in their tool kit to help find people that get lost in the forested areas around PRFN (Figure 15). It has been used previously to search for missing persons and will be used in the future.

Lands Guardians were trained in how to use the thermal functions on the RPAS which had 12 different thermal imaging options, they practiced searching for NSC personnel in the forest and determined which setting worked best in a dense canopy mixed forest environment to find heat signatures of people. It was determined that cycling different thermal filters may work best to try and find the right setting in a search and rescue situation.
